# **Product Introduction of Paint Protection Film X-175T**

# 1 Product structure and materials

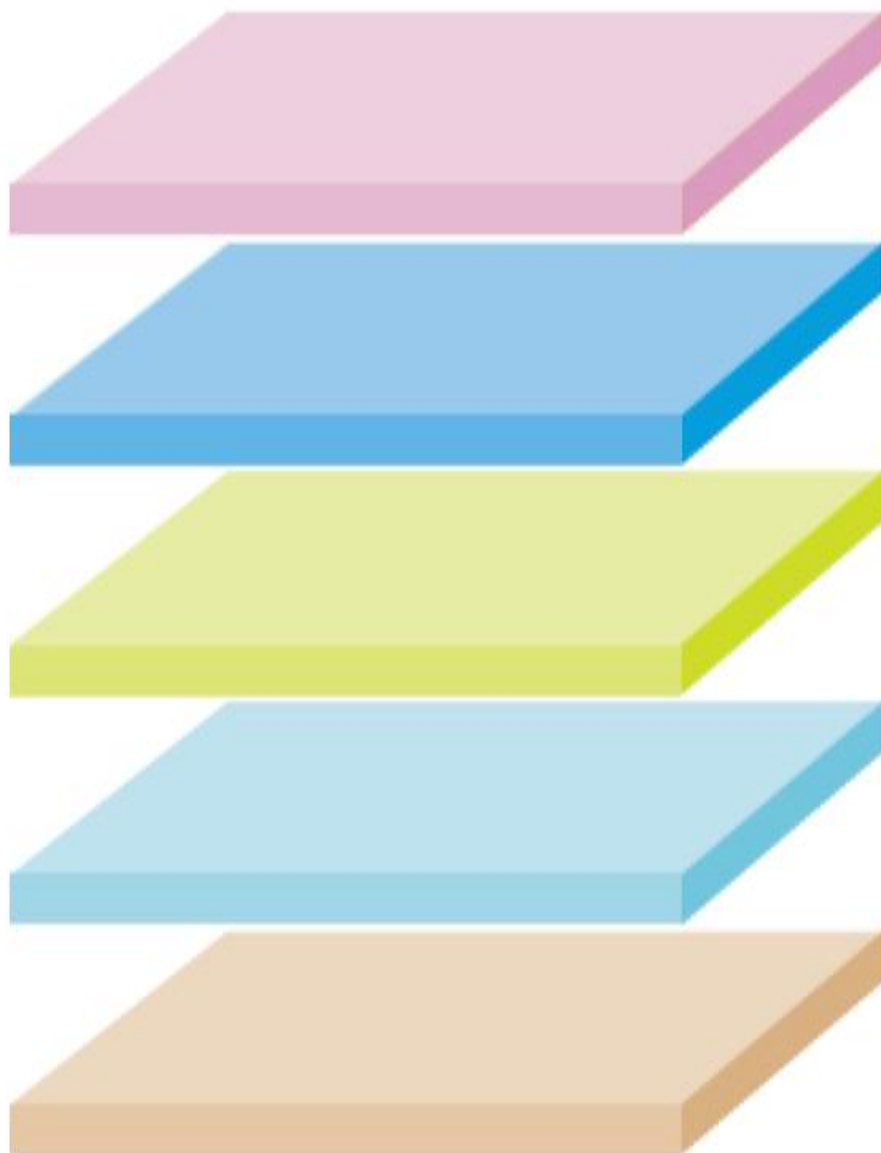
## Ultra high transparency PET film -50μm

Using PET raw film with haze<1% and clarity>99.5% that is super transparent and has high flatness, endowing the repair coating with high brightness and flatness.

## Double anti dense repair coating -7μm

Hydrophilic coating, anti morning light Shuangjie oil pen, and anti dart carburetor cleaning agent, with excellent weather resistance.

## TPU substrate -175μm

Aliphatic polyurethane film, using Kaiyang SMM301, the particles used in the base film are produced by **Lubrizol in the United States**, with a glass transition temperature of 0 °C, and excellent low-temperature construction performance and weather resistance. The base film is clear, ensuring ultra-high brightness of the product.

## Installation layer -30μm

Using **American Ashland adhesive 951059**, with a thickness of 30μm, it has good mounting performance and weather resistance.

## Matte release film -92μm

High matte release film, with a light transmittance of less than 10%. This thickness and matte finish are modeled after American car clothing, giving the product an overall texture.

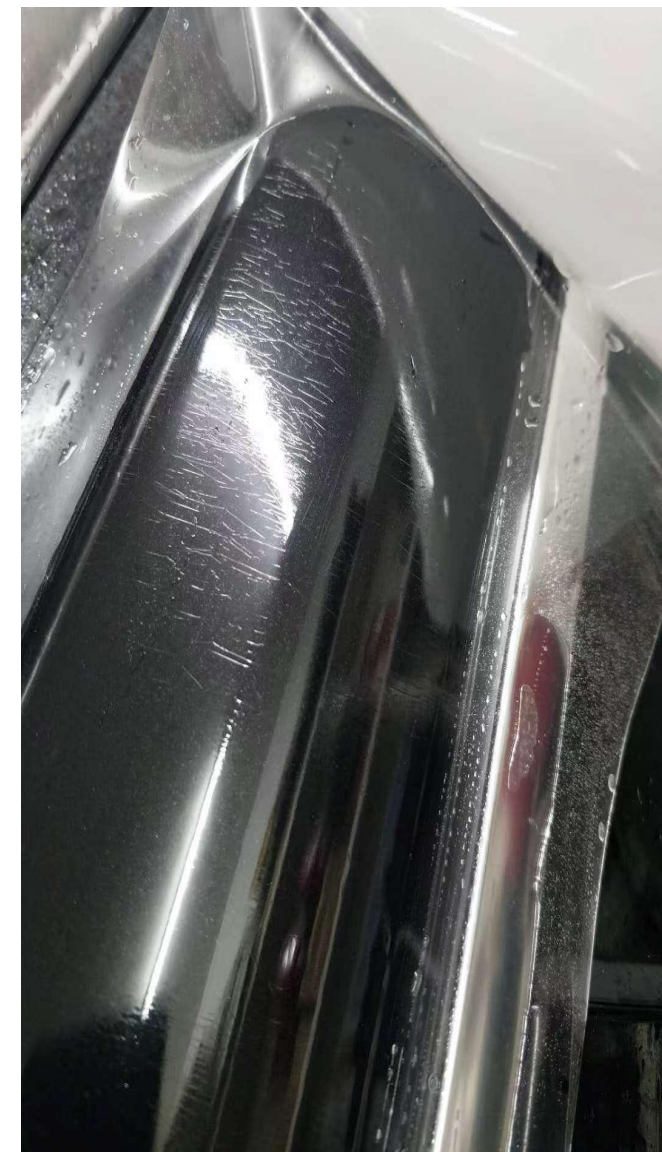
## 1. Curly hair with hoarseness

**Exception description:** Tear off the protective film and roll it into small rolls along the repair layer. After leaving it for a period of time, matte marks may appear (the colder the weather, the more likely they are to appear).

**Cause analysis:** This product uses Kaiyang based film SMM301 coated with a high hardness, high density anti fouling coating. The hardness and density of the repair coating are much higher than those of the TPU substrate. At the same temperature, the molecular activity of SMM301 is higher than that of the repair coating. The lower the temperature, the greater the difference in activity. When the product is compressed or folded along the repair coating and external force is released, both the repair coating and SMM301 substrate undergo rebound repair. However, due to the large difference in molecular activity, the rebound repair amplitude of the two cannot be synchronized, resulting in the repair coating becoming dull.

**Handling method:** Try not to roll it into small rolls as much as possible. If it is necessary to roll it into small rolls, roll it along the matte release film surface; When the ambient temperature or paint cover temperature is higher than 30 °C, it will recover on its own after being left for 1-2 hours. If the ambient temperature or paint cover temperature is lower than 30 °C, it can be restored by pouring hot water at 70 °C or above.

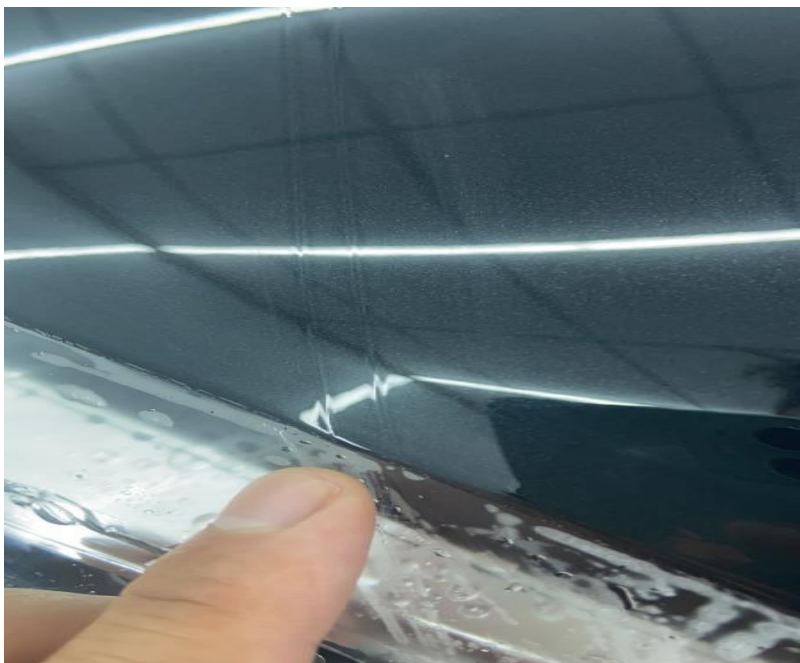
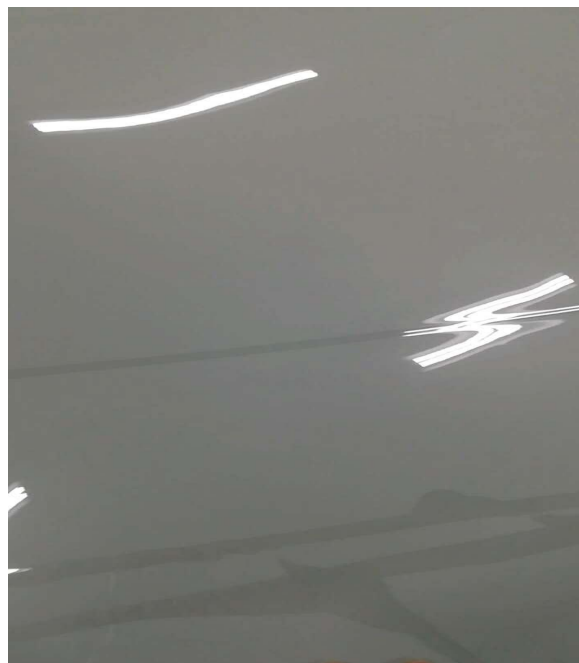
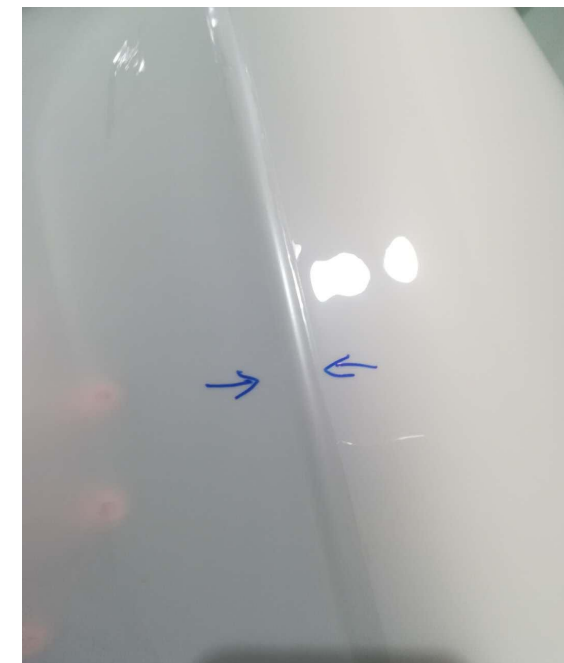
## 3. Membrane imprint

**Exception description:** Non bottom products were found to have horizontal marks after being attached to the car.

**Cause analysis:** This phenomenon is caused by the delamination of the protective film and the use layer, which leads to air entering.

**Handling method:** After cutting the sample sheet, the small support membrane should be promptly wound tightly and adhered to the remaining material; The flat film should avoid curling along the protective film without tearing it off; Remove the protective film before pasting and observe the appearance for any abnormalities before getting on the car.

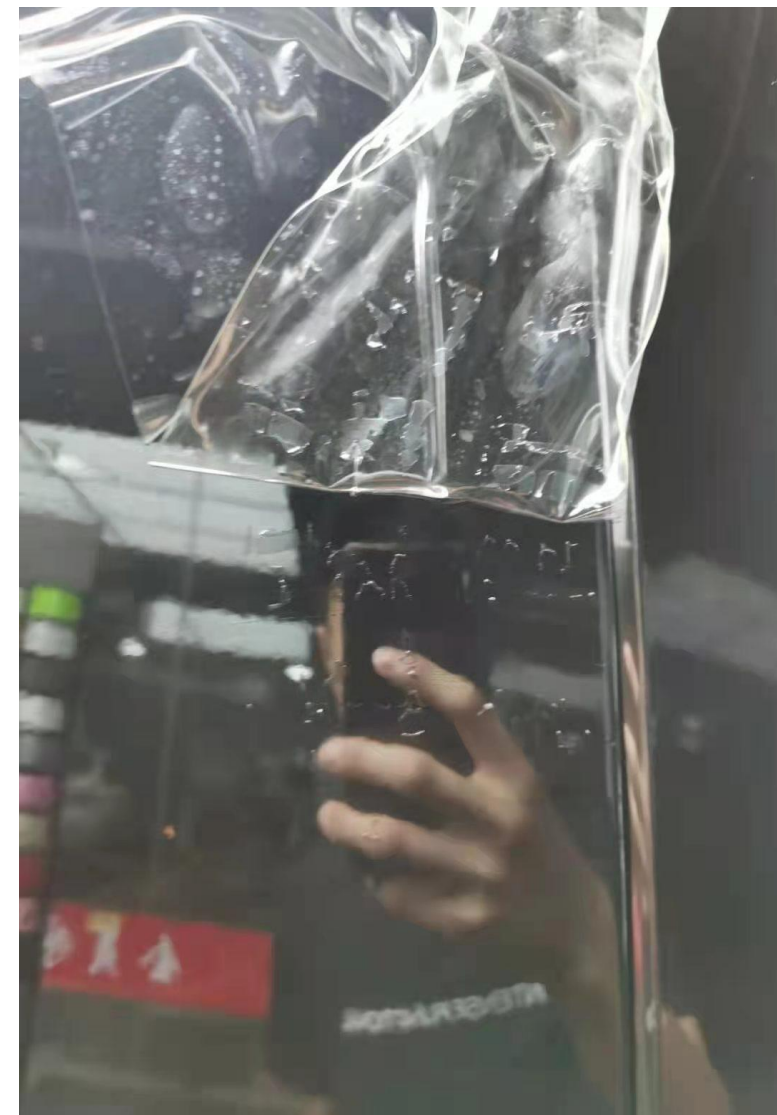
## 4. Low temperature tear film residue adhesive

**Exception description:** Tearing off the paint protection film when the ambient temperature or body temperature is below 10 °C may result in serious adhesive residue.

**Cause analysis:** The installation adhesive for TPU paint protection film uses acrylic pressure-sensitive adhesive, which is easy to wet the surface of high surface energy substrates and difficult to wet the surface of low surface energy substrates. Generally, the surface energy of highly polar polymers is higher than that of non-polar polymers. Under low temperature conditions, the surface polarity of TPU base film will decrease, leading to a decrease in the wettability of acrylic pressure-sensitive adhesive, resulting in residual adhesive when the film is peeled off.

**Handling method:** Try to avoid tearing off the film at low temperatures as much as possible; If it is necessary to tear off the film, it is recommended to pour hot water on the surface of the film before tearing to increase the temperature of the paint protection film, and then immediately proceed with tearing off the film.

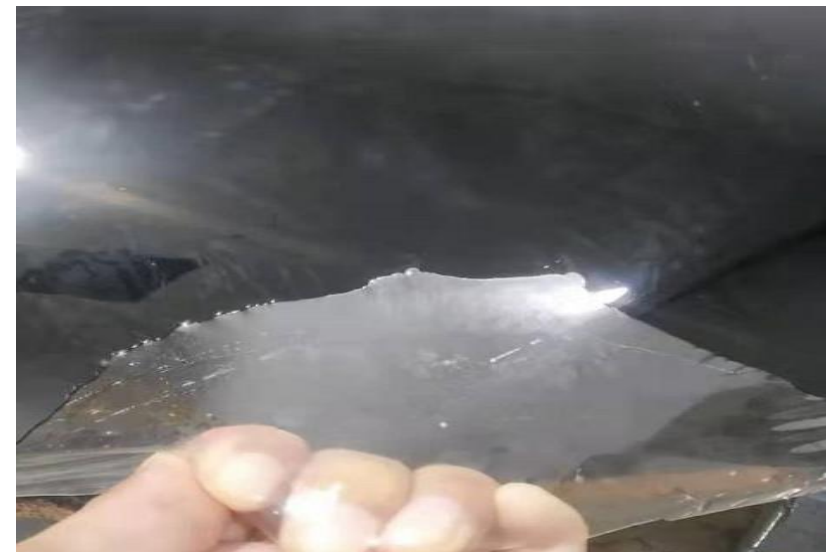
## 5. High temperature tear film residue adhesive

**Exception description:** Long term exposure to sunlight or prolonged driving of the car can cause the body (especially the front hood) to overheat for a long time, resulting in residual adhesive when peeling off the film.

**Cause analysis:** The higher the temperature of the paint surface, the better the wettability of the pressure-sensitive adhesive, and the stronger the adhesion with the paint surface. However, prolonged high temperature can lead to a decrease in the cohesion of the pressure-sensitive adhesive, and tearing off the film can easily result in residual adhesive.

**Handling method:** Wait for the body temperature to drop below 40 °C before tearing off the film. If there is still residual adhesive, **use a small angle to tear off the film. The larger the angle, the greater the cohesion of the adhesive.**

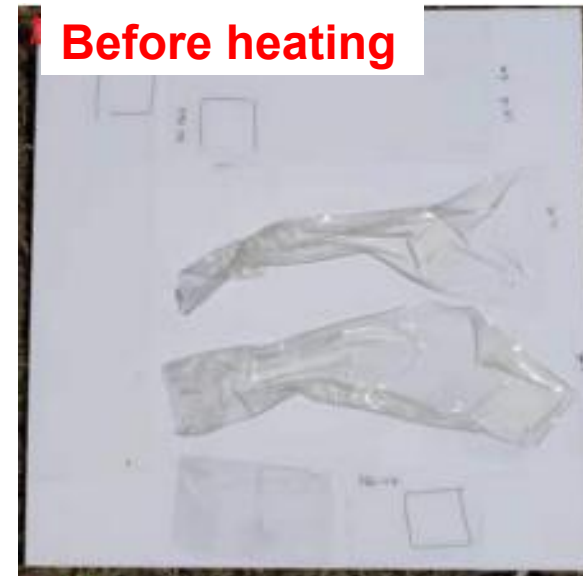
Before heating

**Exception description:** Shortly after the car was installed, the paint protection film appeared slightly yellowish.

**Cause analysis:** The paint protection film will leave a small amount of solvent residue. If driving at night after installing the paint protection film causes the body temperature to rise, the residual solvent will undergo a reversible complexation reaction with certain substances and appear yellow.

**Handling method:** This reaction is UV reversible, and it will return colorless after being exposed to sunlight for more than half an hour. Moreover, the solvent will completely evaporate after exposure to sunlight, and yellowing will no longer occur.

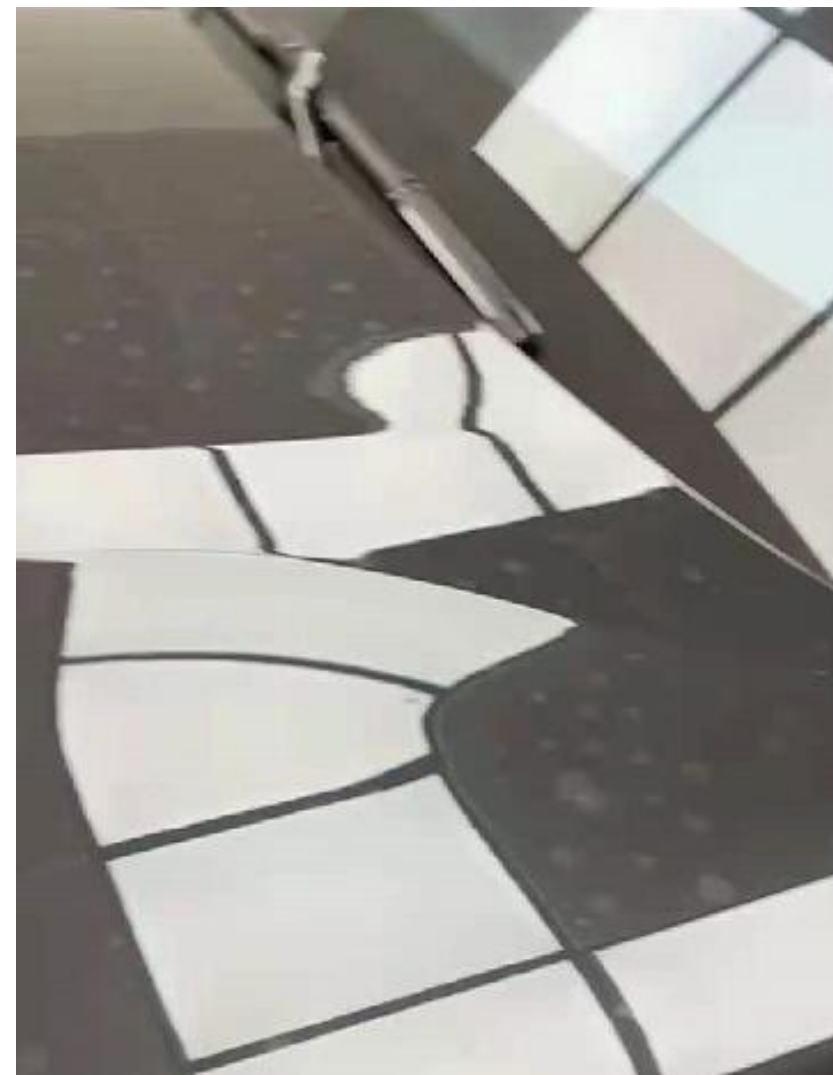
## 7. Spot phenomenon appeared shortly after applying the film

**Exception description:** The protective film on the car's paint surface soon developed spots.

**Cause analysis:** Double anti paint protection film, especially for oil resistant pens, has a relatively dense repair coating. If the water dries on its own after being exposed to water, it will react with the residual unreacted substances (residual double bonds) in the repair coating for sufficient time to produce a white substance (not rain damage the coating and form rain spots). Due to the high density of the coating, it is not easy to come out.

**Handling method:** In the early stages of use, try not to let the water droplets evaporate and dry themselves as much as possible after being soaked in water. These residual unreacted substances will disappear in sunlight for about 1-2 weeks, and there is no need to worry about the water droplets evaporating and drying themselves in the future; If spots have already appeared, these white substances will slowly migrate out under sunlight and disappear after about a week of normal use. This phenomenon will not occur again in the future.

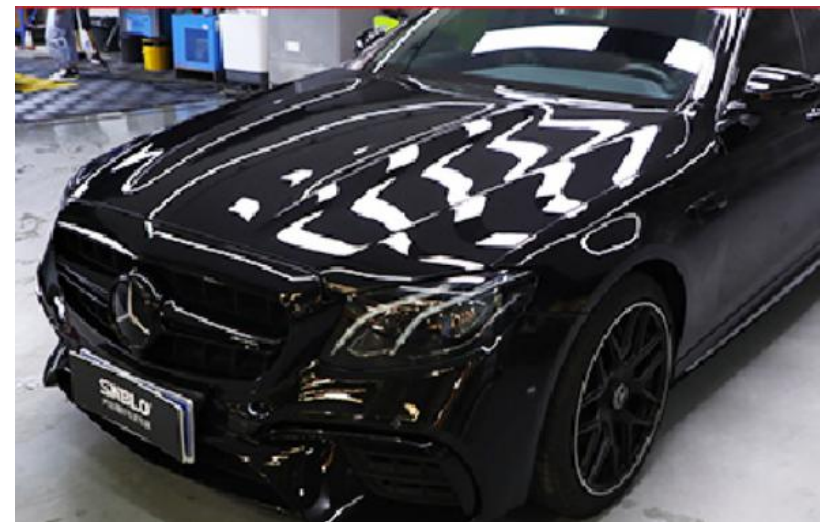
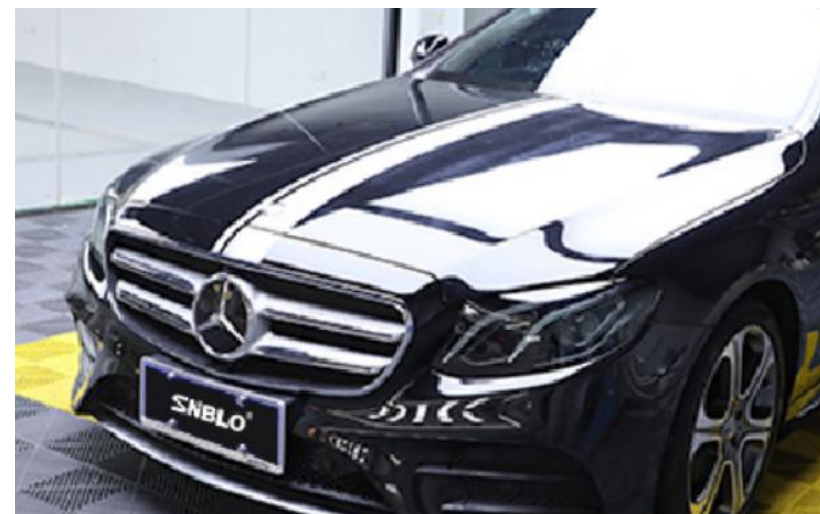
## 8. Brightness decreases after long-term use

**Exception description:** After prolonged use, the brightness of the film may not be as good as when it was just applied.

**Cause analysis:** The repair coating is essentially a mesh polyurethane material. On the one hand, it will expand and soften under direct sunlight (invisible to the naked eye), making it easy for dust to embed and difficult to remove after prolonged adhesion; On the other hand, sewage and sludge contain lipophilic bacteria, which can damage the ester bonds of polyurethane if not removed for a long time, leading to a decrease in brightness.

**Handling method:** Maintain good car washing habits and ensure two or more car washes per month. Cities with severe industrial pollution should pay more attention to car washing and maintenance.
